Trip of Para 275 kV West Left busbar on 14 November 2023

Reviewable Operating Incident
Report under the National
Electricity Rules

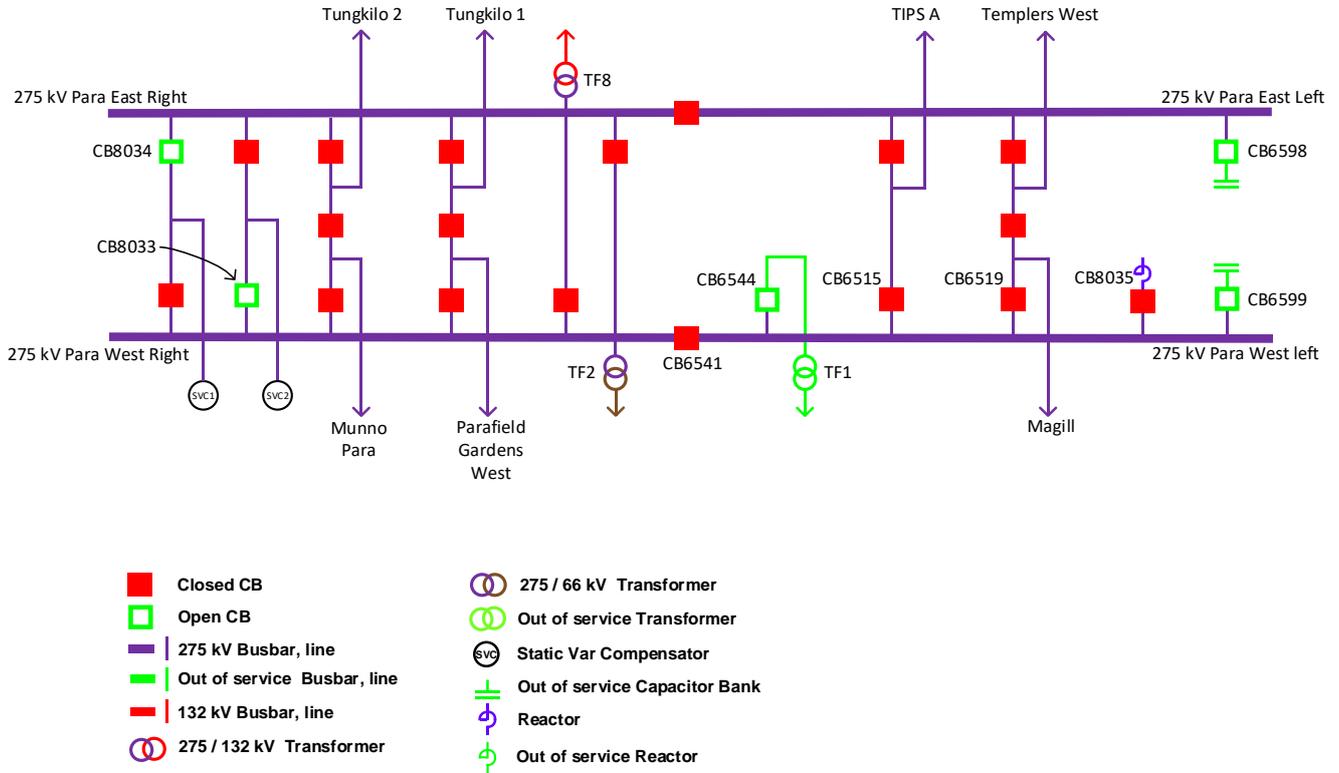
Figure 1 Incident diagram – Para substation equipment status immediately prior to the incident

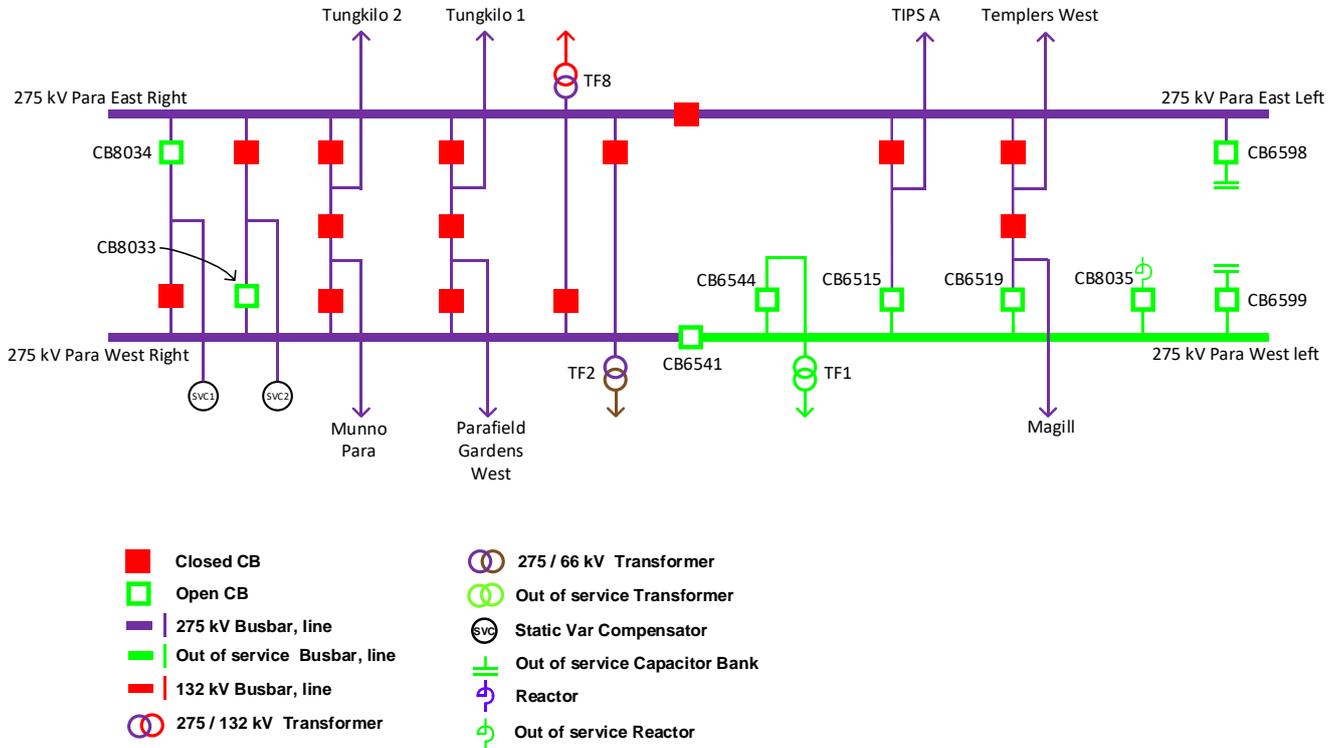
Incident key events	On 14 November 2023, the following events occurred: <ol style="list-style-type: none"> At 1045 hrs, the Para 275 kV West Left busbar set X and set Y protection systems operated and tripped CB 6541, CB 6515, CB 6519 and CB 8035, tripping the Para 275 kV West Left busbar (see Figure 2). At 1124 hrs, the Para 275 kV West Left busbar was returned to service.
Incident cause	Post-incident investigation by ElectraNet has confirmed that: <ul style="list-style-type: none"> At 1045 hrs on 14 November 2023, the Para 275 kV West Left busbar set X and set Y protection systems operated when additional earthing was connected to the CT secondaries associated with CB 6544. The earthing of these CT secondaries caused a circulating current in the affected CTs. This circulating current caused the Para 275 kV West Left busbar protection system to operate. Prior to the connection of additional earthing, the 275 kV CTs associated with CB 6544 were not isolated from in-service protection systems, including the Para 275 kV West Left busbar set X and set Y protection systems. A subsequent investigation undertaken by ElectraNet’s MSP has identified that the staff involved in this incident had limited experience in testing of in-service equipment. As such, they were not aware that fitting earth connections to the CT secondary wiring would create circulating current paths and would create a trip risk if no secondary isolations were in place. In addition, the ElectraNet’s MSP has identified that they had no suitable procedures or instructions in place for carrying out this type of work.

Figure 2 Incident diagram – Para substation equipment status immediately following the incident
