POWER SYSTEM OPERATING INCIDENT REPORT TRIP OF TULLY NO.2 132 KV BUSBAR AND TULLY — INGHAM SOUTH TEE CARDWELL 132 KV LINE ON 9 MAY 2011

PREPARED BY:	Electricity System Operations Planning and Performance
VERSION:	1.0
DATE:	9 September 2011
FINAL

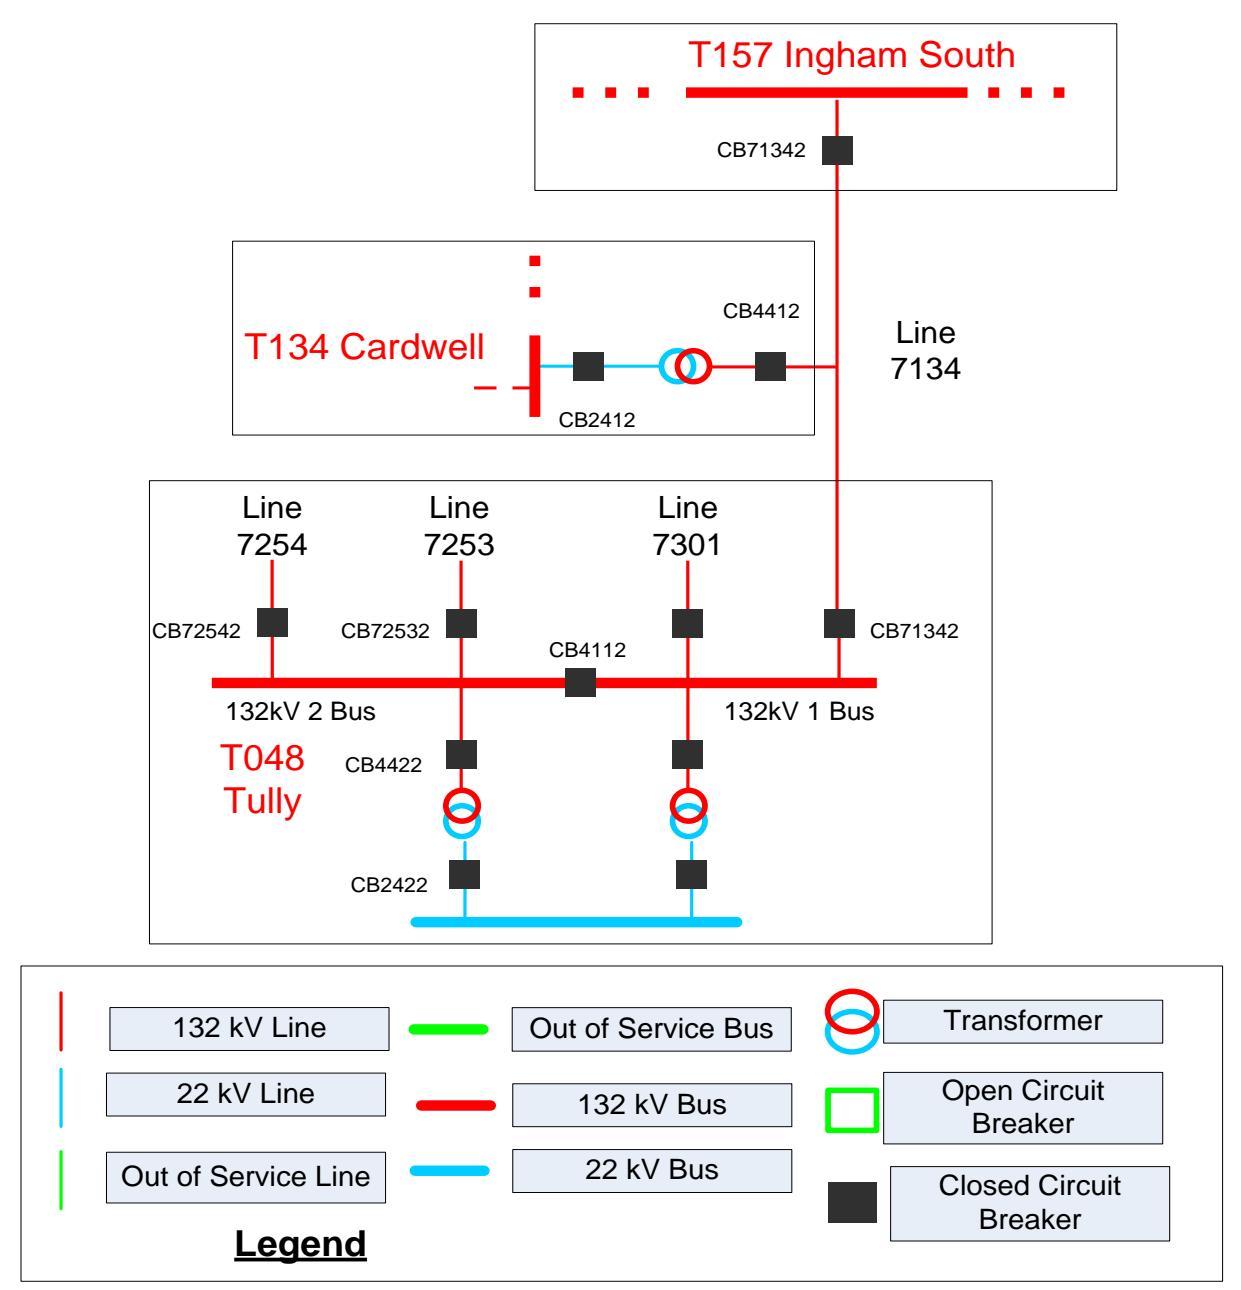
Figure 1: Status of power system prior to the system incident

Figure 1 below shows the status of the power system prior to the incident. For clarity only system components relevant to this incident has been included in the diagram.
