Power System Oscillations in South Australia on 23 June 2022

February 2023

Reviewable Operating Incident
Report under the National
Electricity Rules

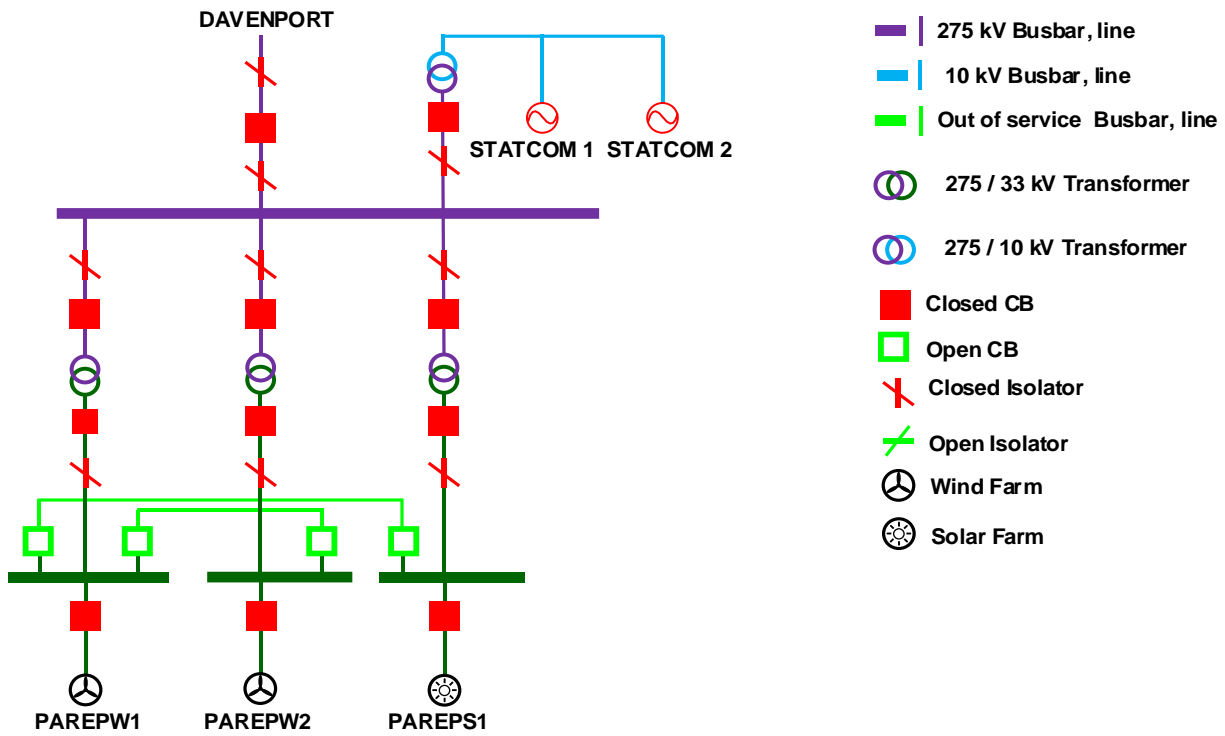
Figure 5 PAREP connection arrangement

PAREP is an integrated wind and solar facility consisting of a 210 megawatts (MW) wind farm and 99 MW solar farm, and a total registered capacity of 270 MW. The overall facility is being registered in stages, with only the wind farm component registered (and undergoing commissioning) at the time of the incident. PAREP is connected to the Davenport 275 kilovolts (kV) substation, south-east of Port Augusta in South Australia (see Figure 5 in Appendix A1).
