Final Report – Trip of Torrens Island A and B West 275 kV busbars on 12 March 2021

November 2021

Reviewable Operating Incident Report under the
National Electricity Rules

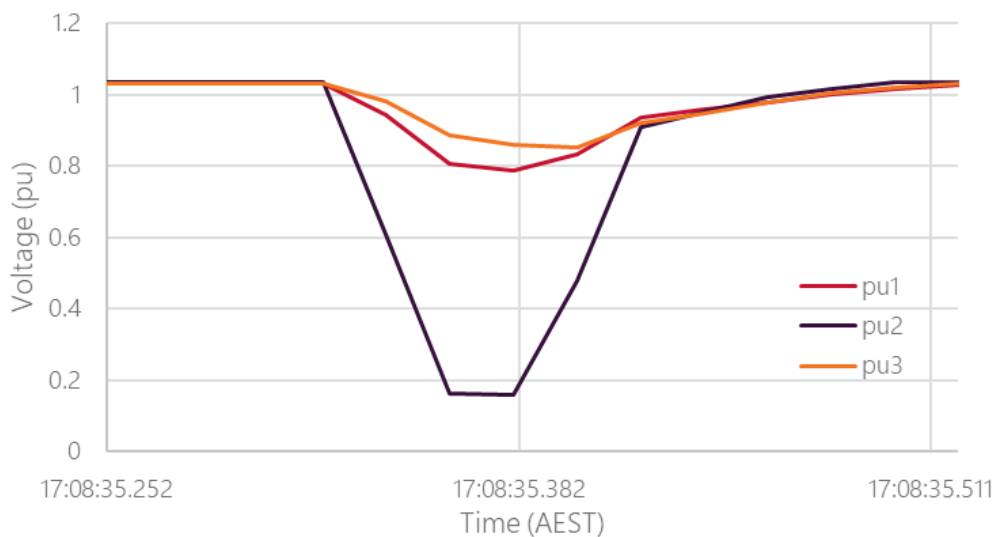
High speed monitoring at Magill recorded a minimum voltage of 0.16 pu on a single phase (and a minimum of 0.60 pu positive sequence) during the fault, as shown in Figure 2. Voltage disturbances of this depth on previous occasions have been observed to result in more than 20% of DPV in SA disconnecting, and significant load disconnection, as discussed further in Appendix A3.

Figure 2 Three phase voltage measured at Magill

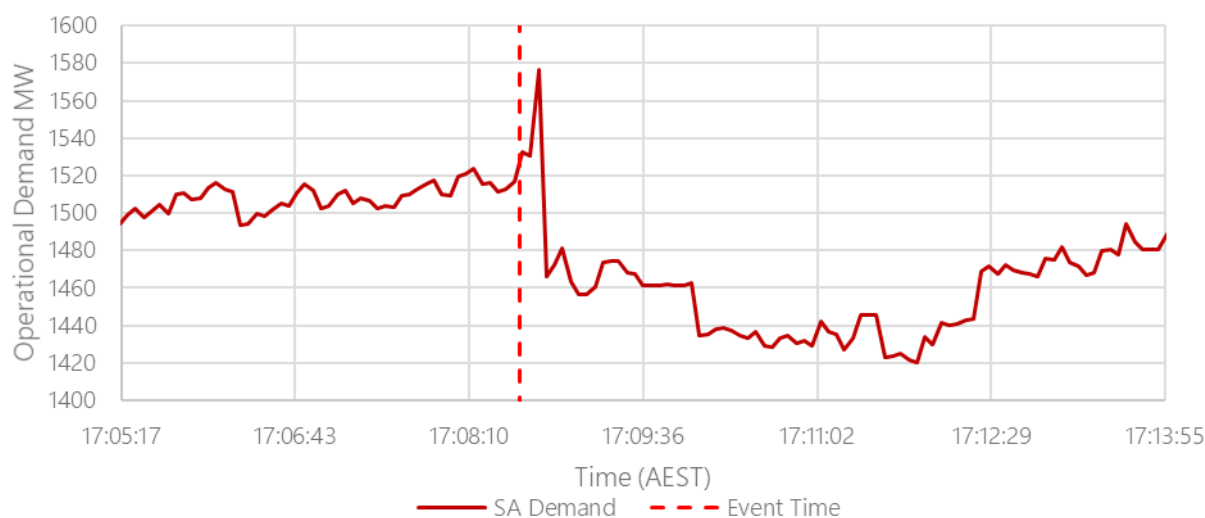
Prior to the event, total operational demand in South Australia was estimated at 1,520 MW. Following the event, demand reduced to less than 1,430 MW (as shown in Figure 3), a net load reduction of approximately 90 MW. It is estimated that approximately 70 MW of DPV disconnected in response to the voltage disturbance, as discussed further in Appendix A3. This level of DPV disconnection is somewhat lower than observed in previous similar disturbances. The causes for this remain under investigation. Since DPV disconnection offsets load disconnection, it is estimated that a total of approximately 160 MW of underlying load disconnected in response to this event.

Figure 3 South Australia load response

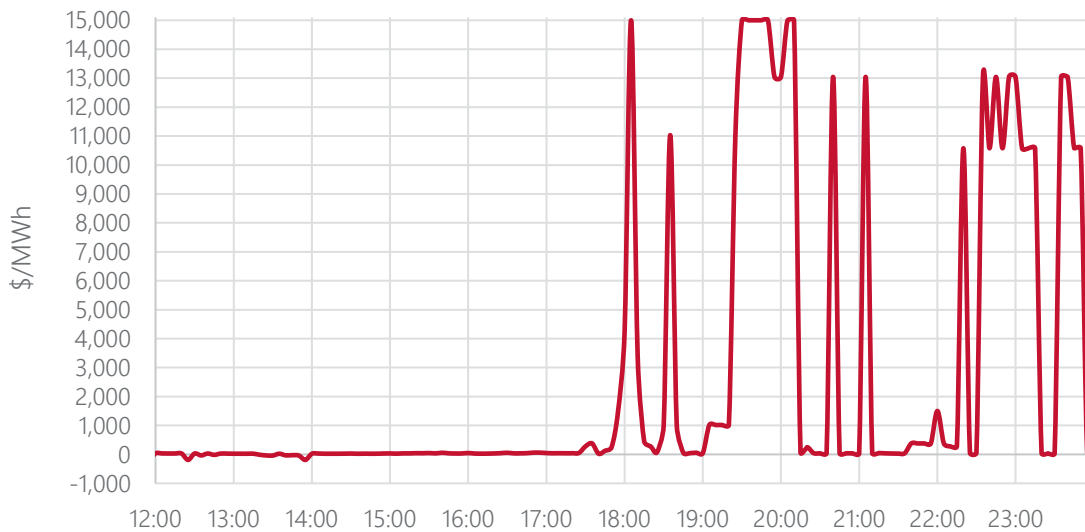
The daily average trading price (30-minute basis) for 12 March 2021 was \$1,335/MWh. Figure 4 below presents the 5-minute dispatch price outcomes on 12 March 2021.

Figure 4 SA 5-minute dispatch price from 12:00 hrs on 12 March 2021 to 00:00 on 13 March 2021

- An initial price spike of \$15,000/MWh was observed for DI ending 1805 hrs.
- Prices remained above \$11,000/MWh between DI ending 1925 hrs and 2010 hrs.
- There was a period of prolonged high prices from DI ending 2235 hrs.

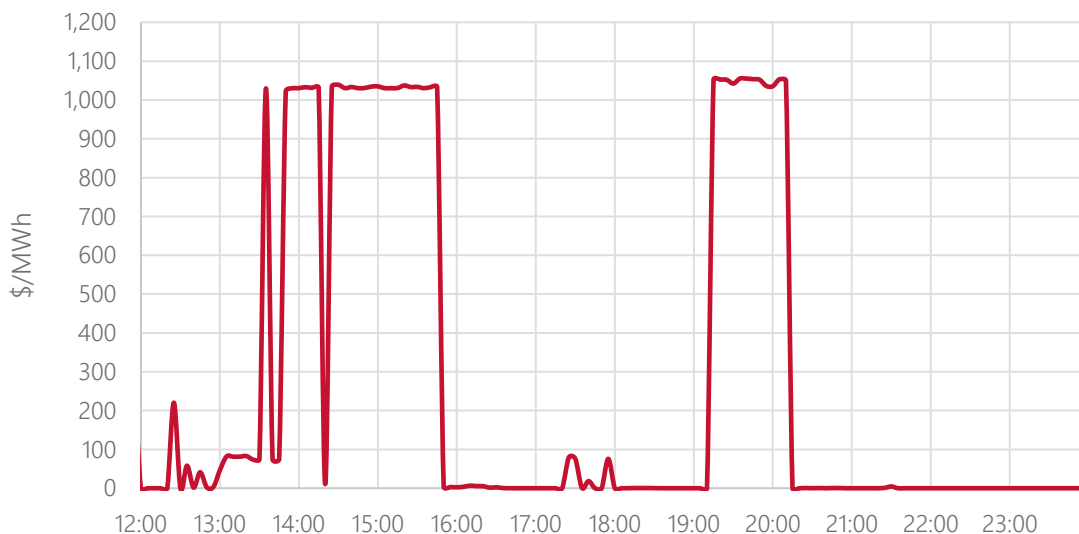
As shown in Figure 5, between 1915 hrs and 2010 hrs on 12 March 2021 the price for the South Australian 60 Second Lower FCAS service remained above \$1,000/MWh, peaking at \$1,055/MWh. High prices over this period were largely due to limited Lower 60 Second FCAS supply from Torrens Island Power Station due to the incident. High prices had also been observed earlier in the day as the MOPS-MLTS outage necessitated local South Australian Lower FCAS requirements²⁷. Figure 5 shows the Lower 60 Second FCAS price outcomes from on 12 March 2021.

Figure 5 SA Lower 60 Second FCAS price from 12:00 hrs on 12 March 2021 to 00:00 on 13 March 2021

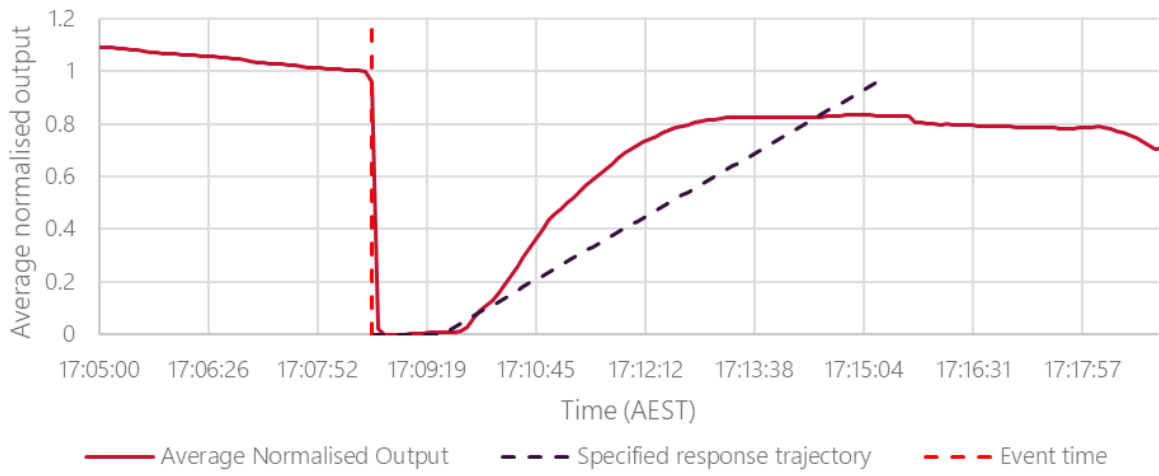
For inverters installed under the 2015 standard in the Solar Analytics sample of five-second resolution data, 458 systems were observed to disconnect. The aggregate normalised³⁵ generation profile from these systems is shown in Figure 9. The aggregate profile remained close to zero for approximately 1.5 minutes, then ramped up somewhat faster than the response trajectory specified in the 2015 standard (which requires a six-minute ramp rate limitation).

Figure 9 Normalised aggregate generation profile for distributed PV systems under the 2015 standard that disconnected
